ICCROM Heritage Recovery Program Module 4 - Documentation Of the Prayer House Of Our Lady Of The Hour Church, Mosul

Restoration and Rehabilitation of The Prayer House

Drawing Title: **Key plan**

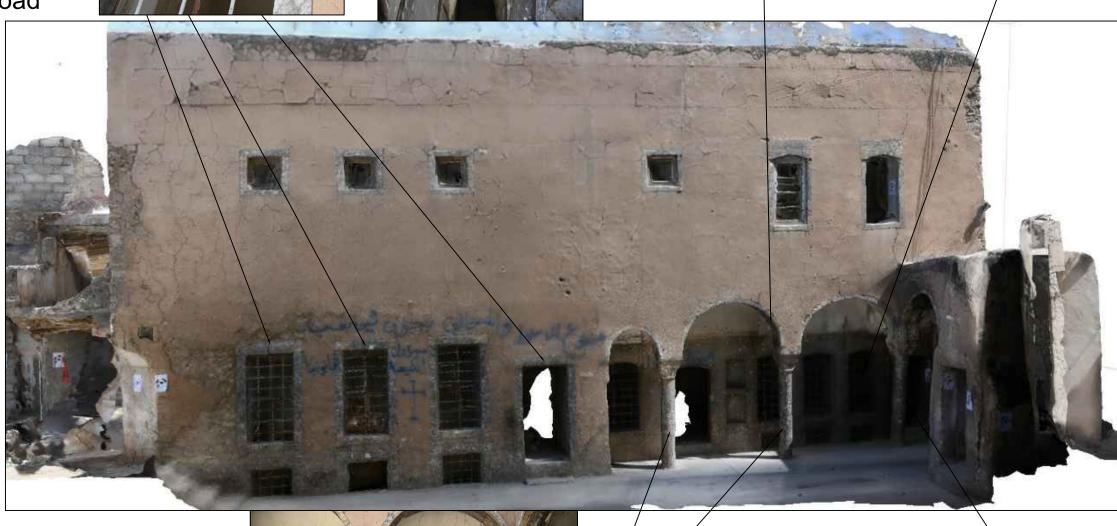
A.5.1

cracks in alabaster that covering the edge of the windows and doors due to the bending of the high load

at some timethey knew that the building is moving so they added one bar which is not enough

the protection bars of the windows are rusted

bending of columns in to direction of the alley because of the settlement of the foundation

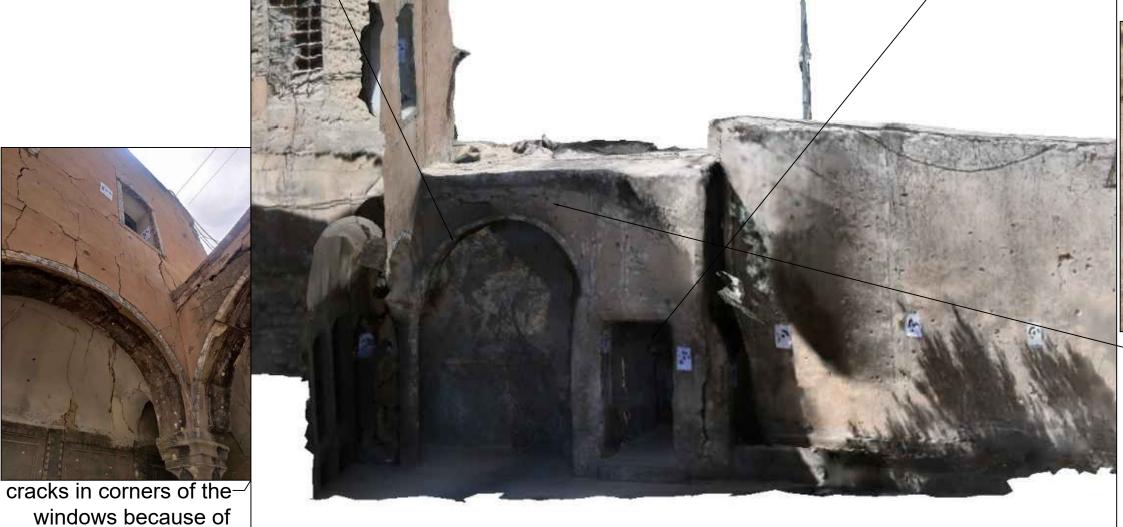
A.5.2

the arc isbuilt of separated parts that is not connected well and its **Exhibition** to collapse

the small door Exhibition to collapse

the front facade is not connected to the hall facade

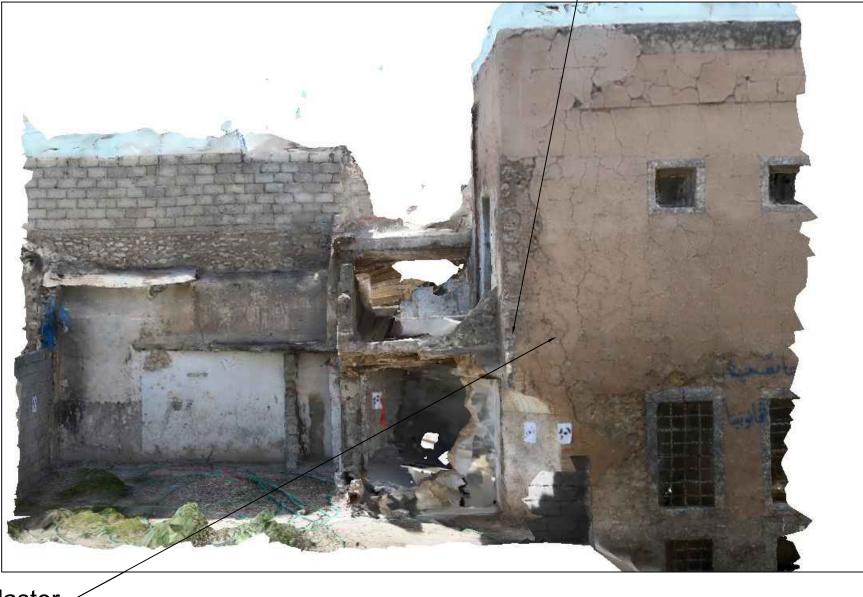
corners are build from pieces of a local marbles

cracks and fallen plasterin the hall faced because of the moisture and many other problem

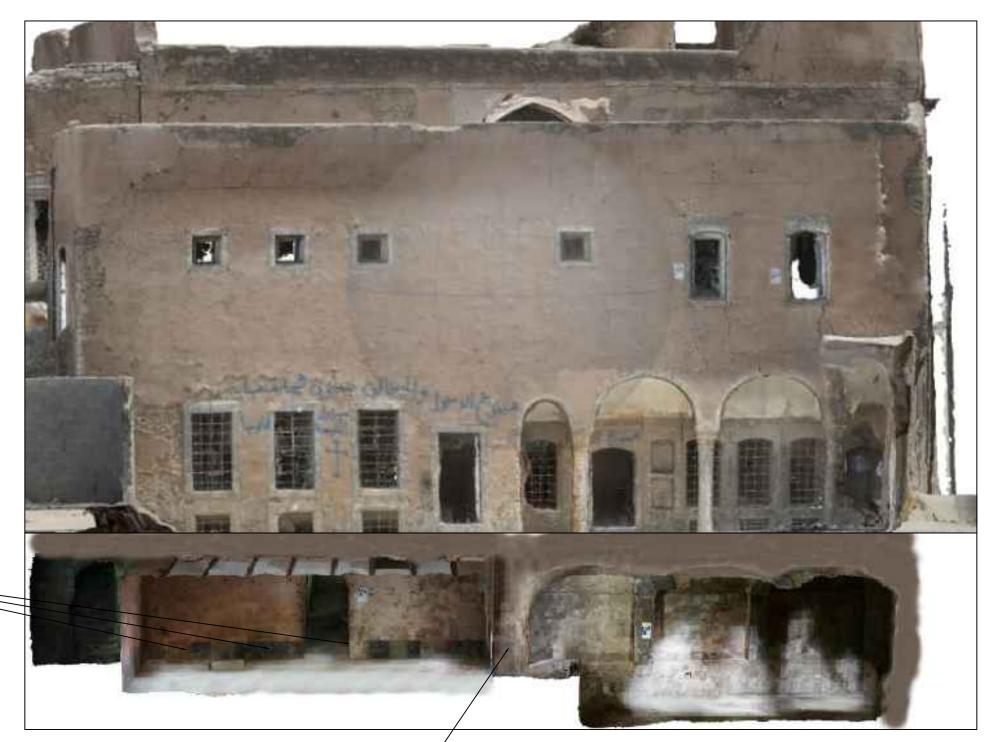
the alabasterof the basement windows is corroded due to the moisture problem because of the concrete floor in the

exterior yard

there was a door here from thebasement below to the court yard

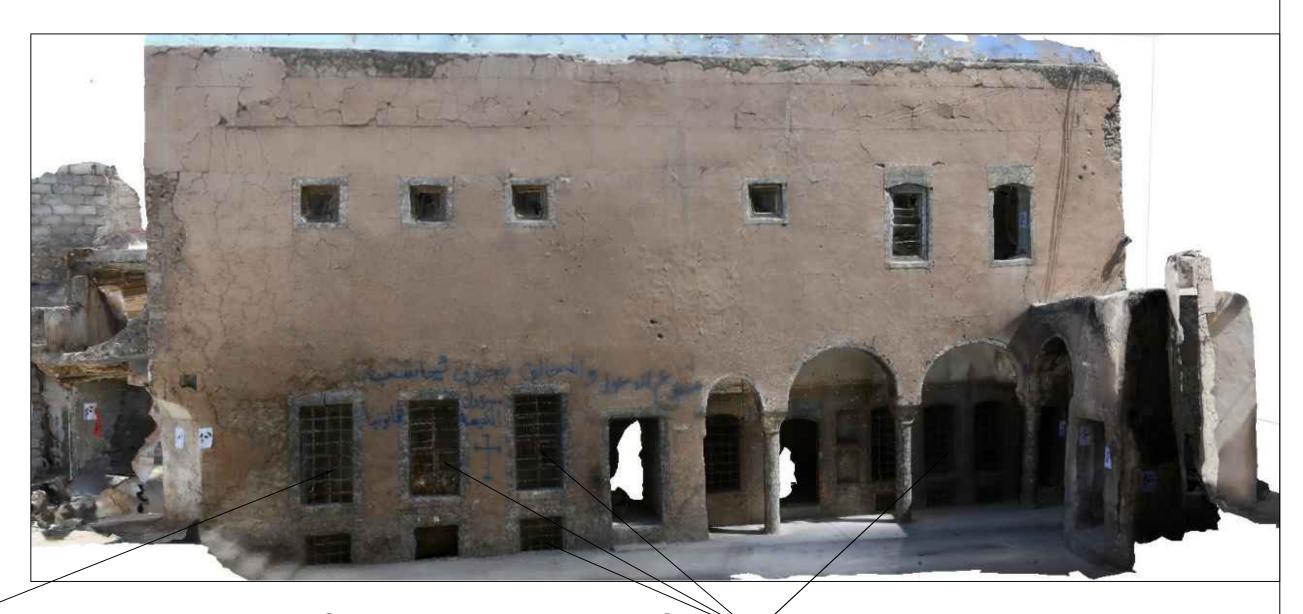
there is to types of protection bars of the windows old and new which are different in shape and spacing

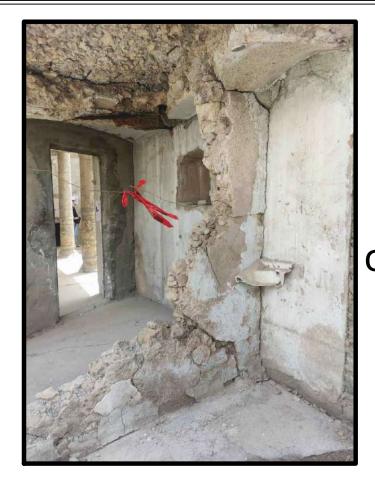
in this place there was a bathroom that causes a licking to the other surrounding rooms

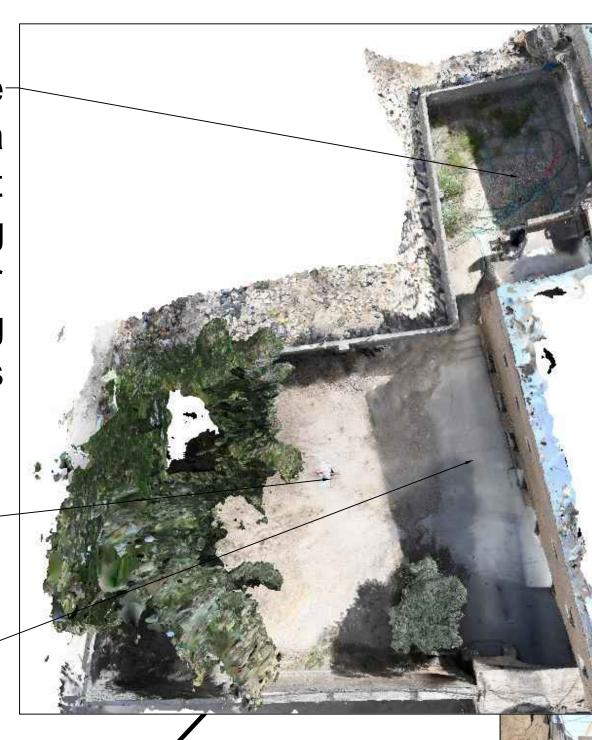
2/06/2022 A.5.6

their is a wellwithout protection

The floor made of concrete

> the source of electricity are not safe and some wires are not secured

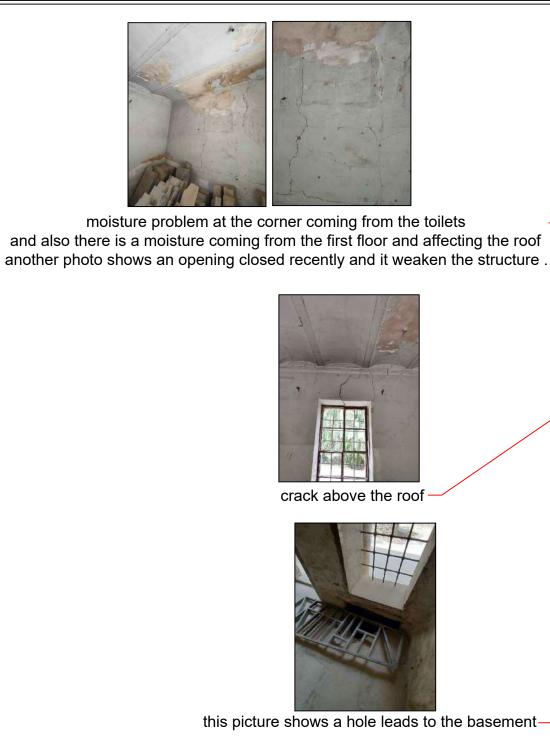
this picture shows a hole leads to the basement-

this wall is not connected very well with the buildingand this caused a crack around the wall

A unique alabaster frame is able to fall.

a door leads to the center courtyard closed recently with bricks and this opening make the building weak

this beam is structurally weak

these two openings weaken the structure and caused big cracks

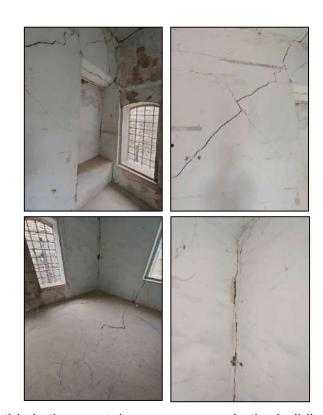
crack above the window

this is the most dangerous room in the buildingit is leaning towards the street and it contains too many cracks (diagonal cracks , cracks at the corners, cracked floor and cracks above the window).

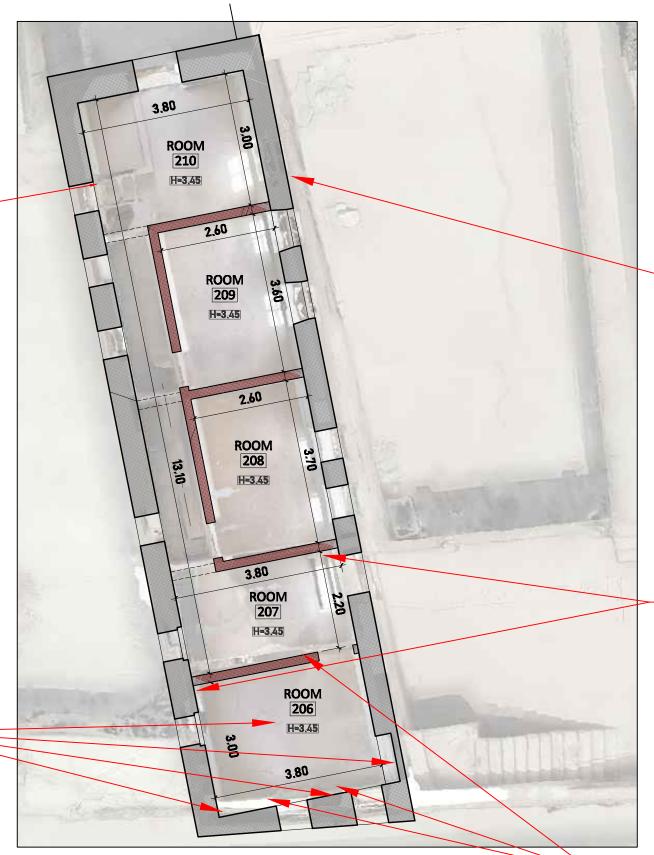
moisture coming from the roof and it is affecting the wall

this photo shows a crack between the interior walls and exterior walls due to weak connection between them and this crack is obviously noticed inside every room

-this wall is suffering from moisture problems it could be a leakage from the drainage pipe

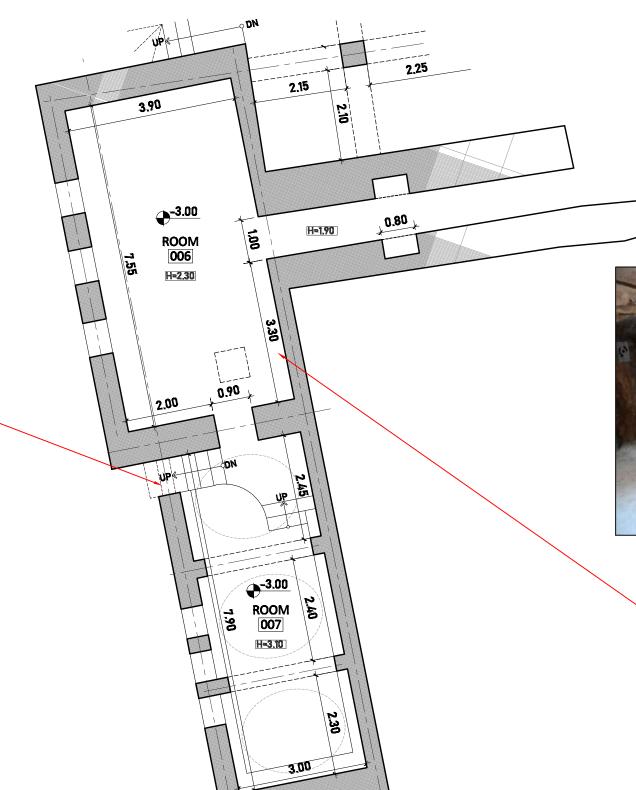
B3.5

A door leads to olive garden closed recently with bricks-

A moisture problem affecting the I sections and the wall

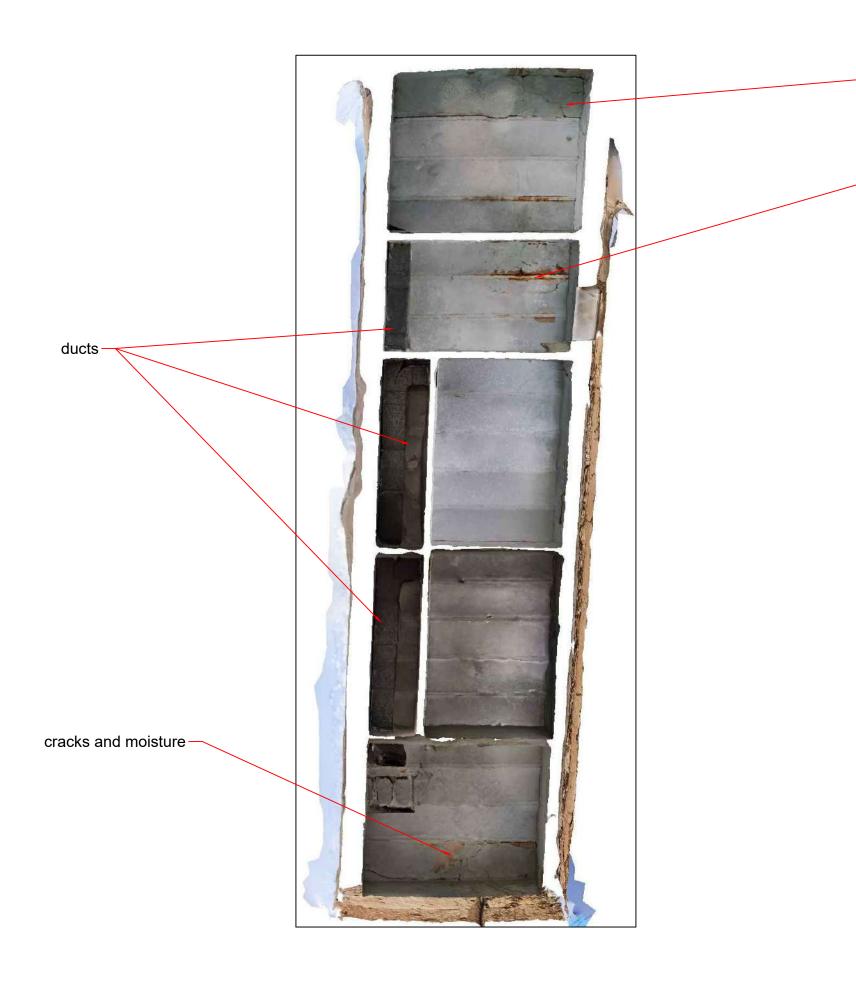
B4.1

Moisture on the ceiling due to drainage issue-

big cracks on the vaults and openings-

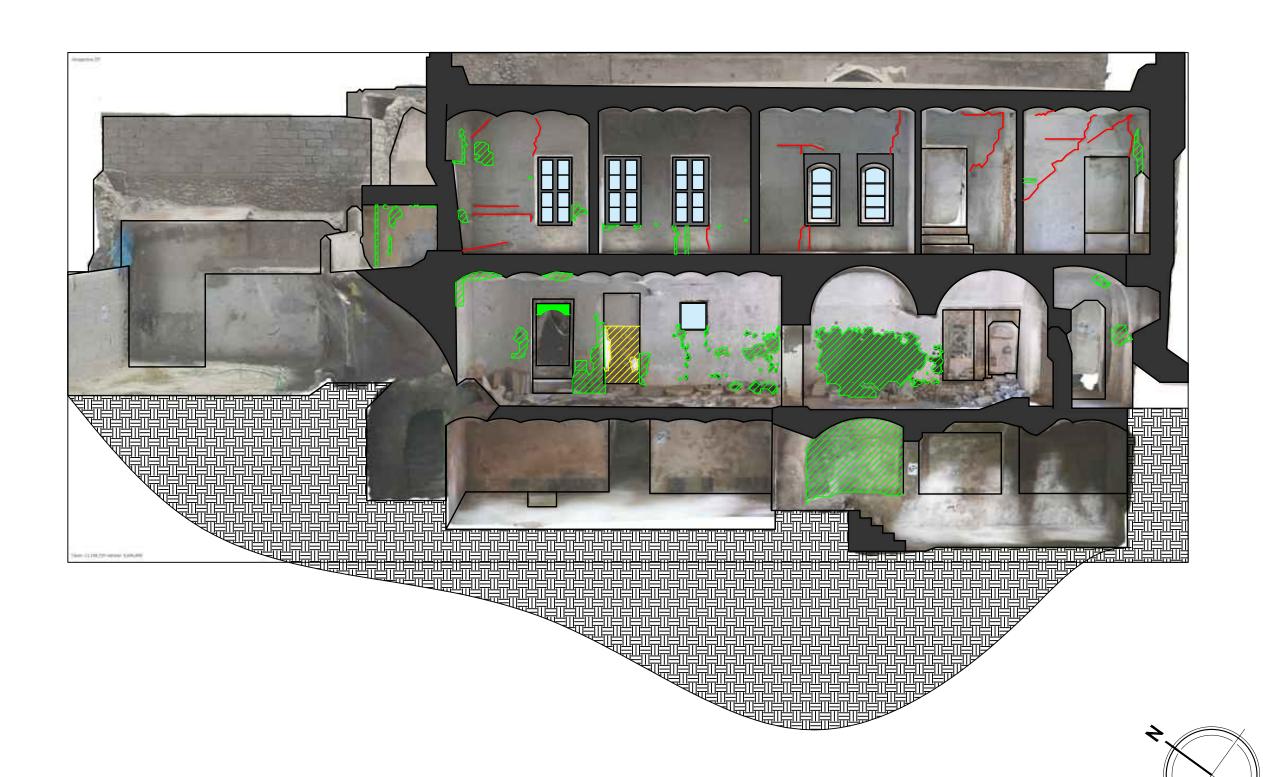
Cracks

-Rusty I sections

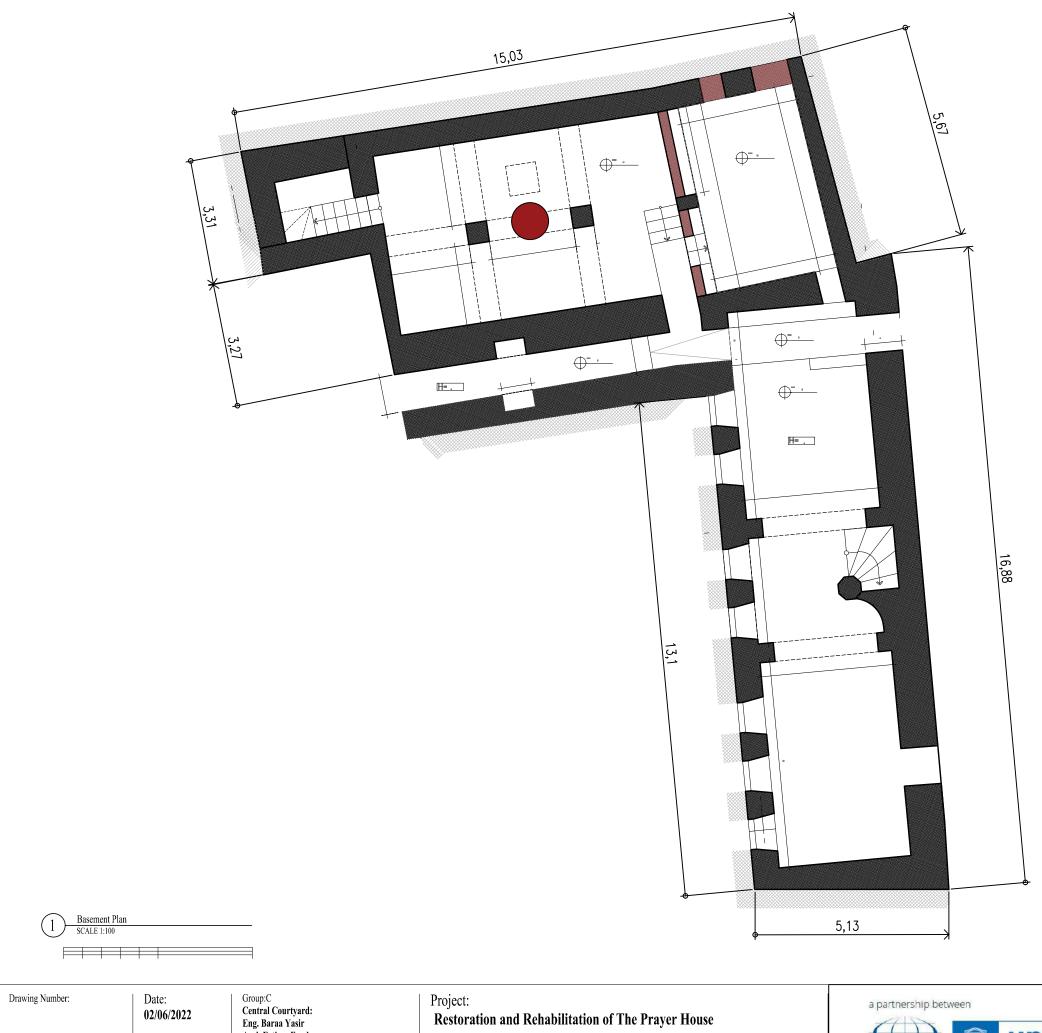
C3.1

The Deepest Basement

It contains a wholes in ceilings for lighting and ventilation but it considered as a dangerous wholes cause it is without iron bars or net for protection

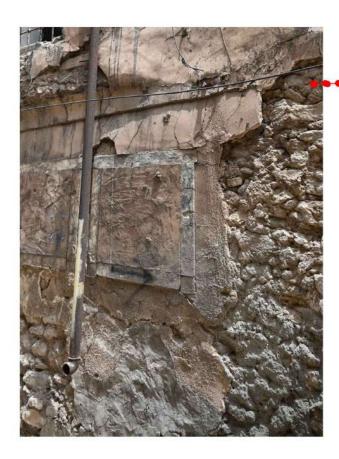
Cracks

The facade had many cracks especialy in the weak places

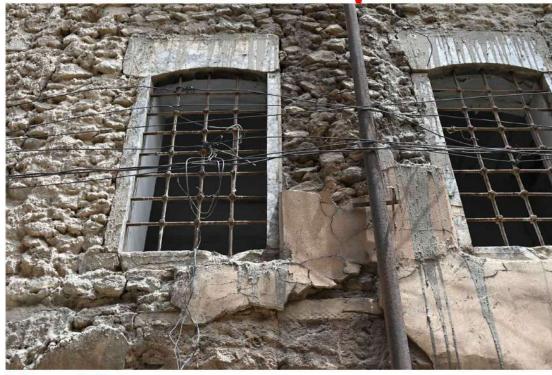
Electricity

the electricity wires very random and not protected in good way the prayer house located in a narrow alley and the electrical bad using may cause dangerous. in addition to bad apperance for facade

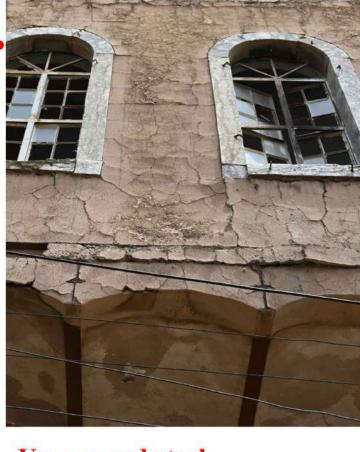
Un covered steel

The erosin of alabaster in the facade which called Medmak because of the bad water drinage of the prayer house and it is came from up floor

I section in the facade which left room in the first floor the material is removed and that cause rust to the steel

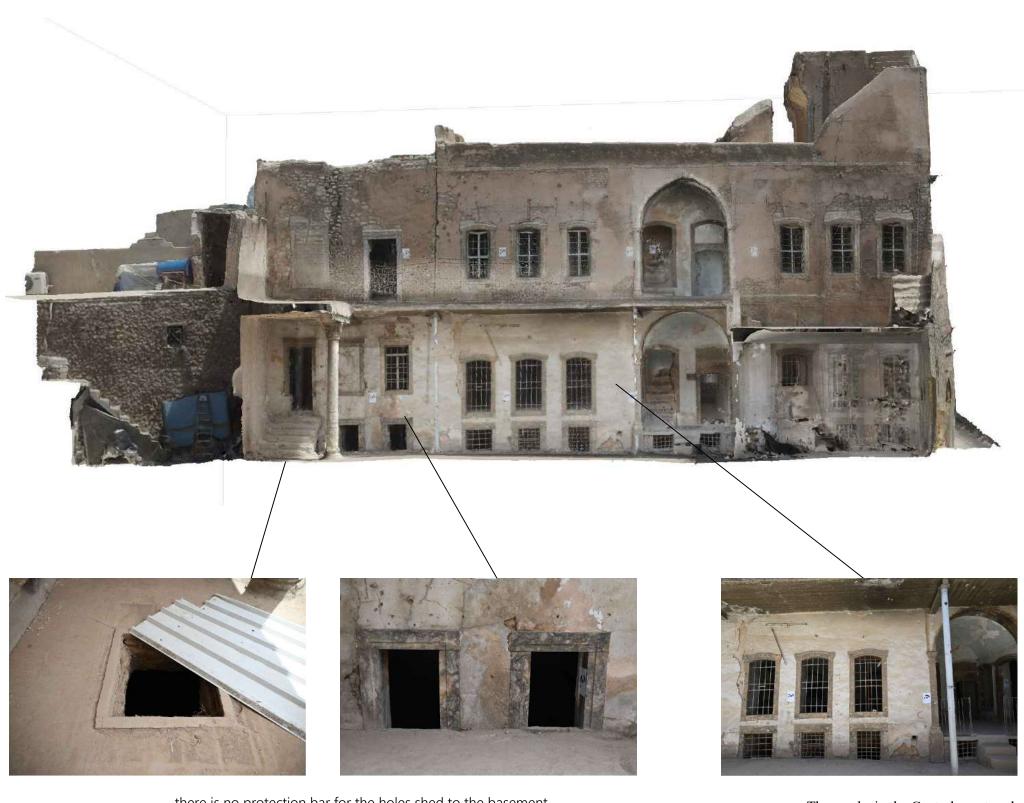
C5.2.1

there is no protection bar for the holes shed to the basement

The cracks in the Central courtyard

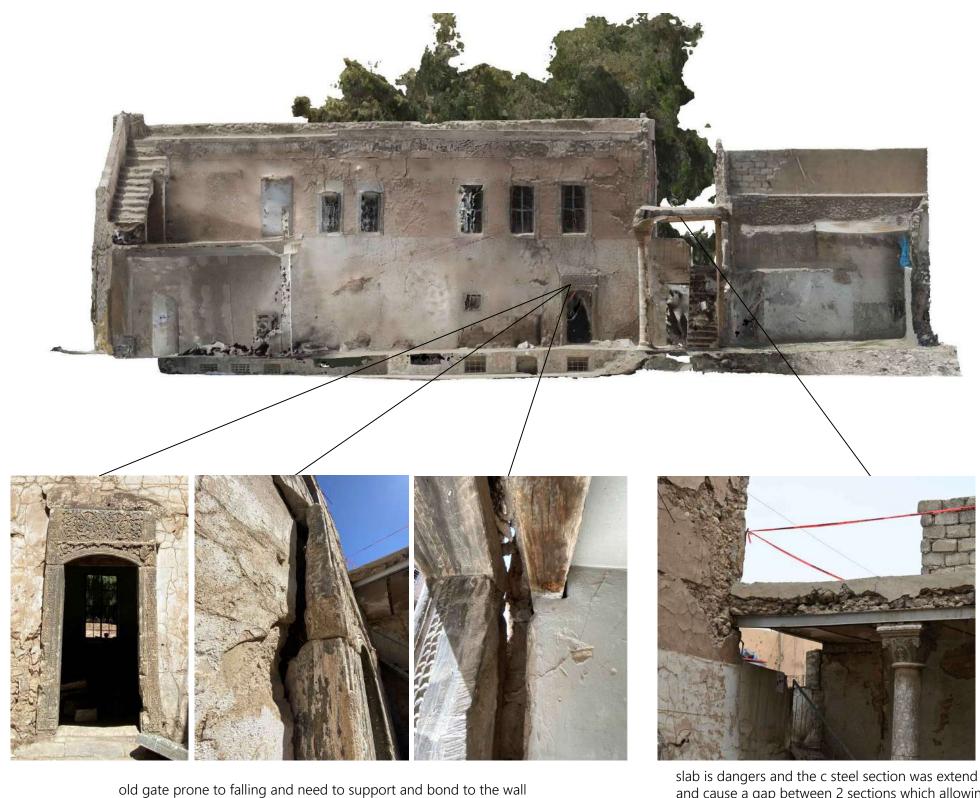
C5.3.1

slab is dangers and the c steel section was extend and cause a gap between 2 sections which allowing to the birds building there nests

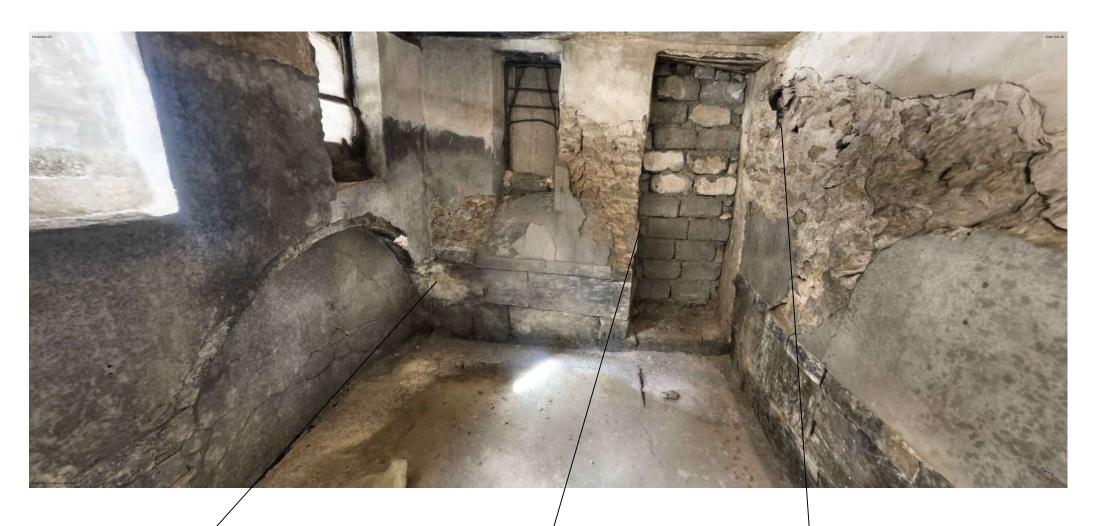
C5.5

ceiling had loss of masonry and cracks due to explosion near by

the wall in the kitchen basement swollen and prone to falling because of the explosion in the near area

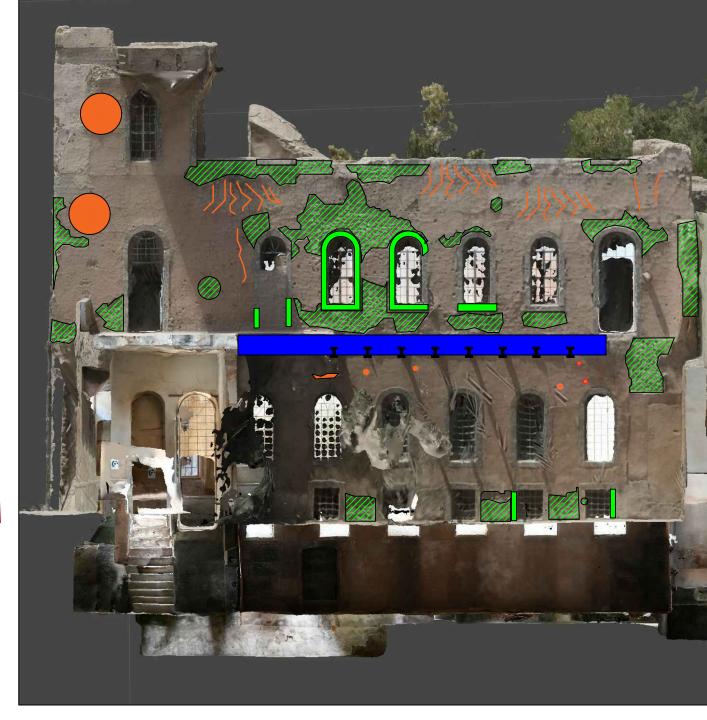
surface crack
plaster loss

I section steel loss damaged alabaster
