SUMMER SCHOOL

# POST-CONFLICT RECOVERY

## CONTEXT Analysis and DOCUMENTATION

Rand Eppich, Ph.D. Architect  
randeppich@gmail.com

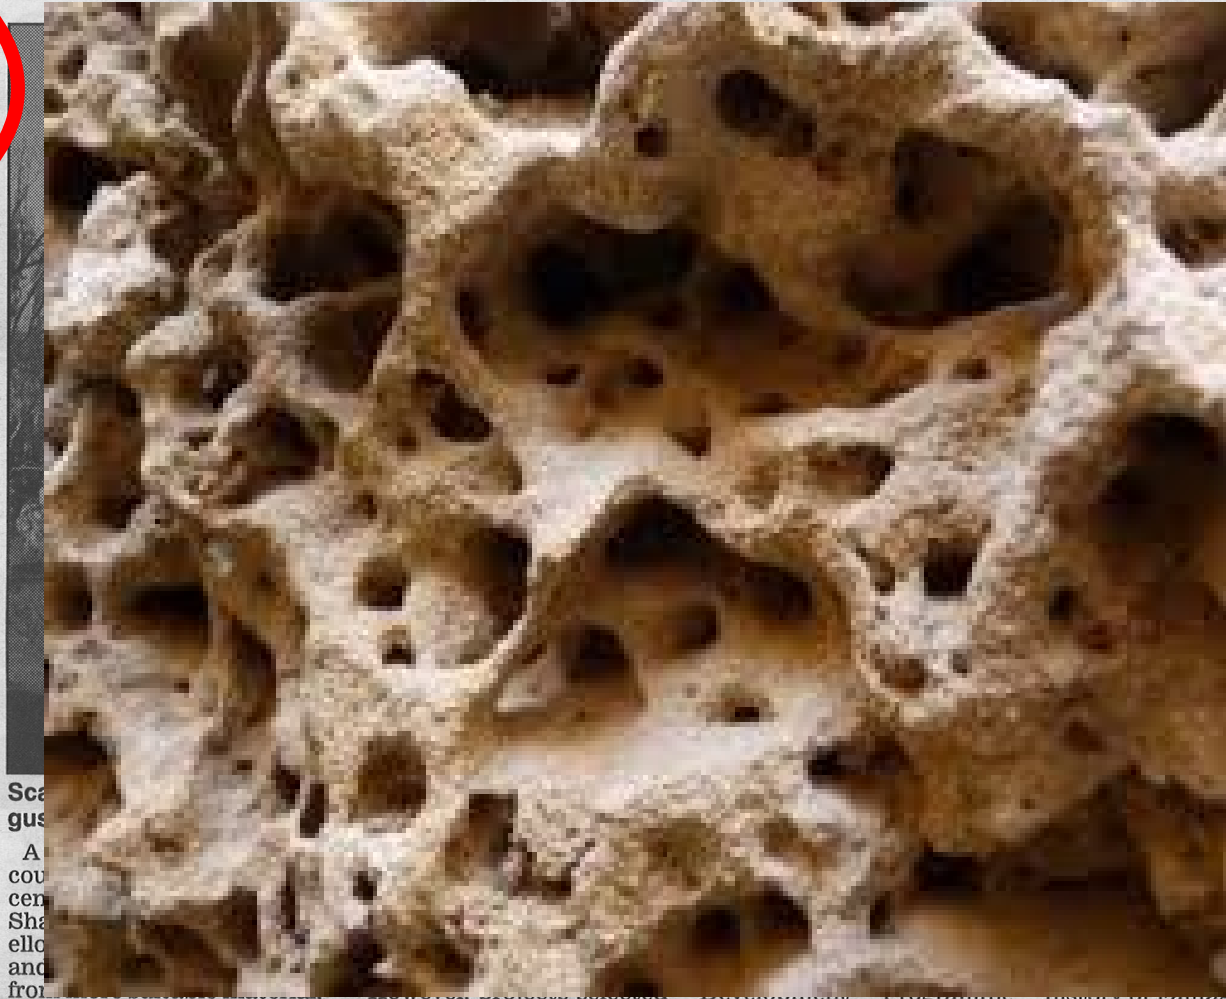
The sandstone complex, with four towers, is a maze of dark alleys, cellars and a large banqueting hall supported by vaulted roofs. Signs of its expansion from a Lusignan fortress to a Venetian one are evident; arrow slits in walls seen from the inner parts of the complex look out onto the Venetian fortification.

Conservationists say the intervention will be as 'light' as possible. Only original materials and mortar will be used, and researchers have already located the ancient quarry where material will be extracted if necessary.

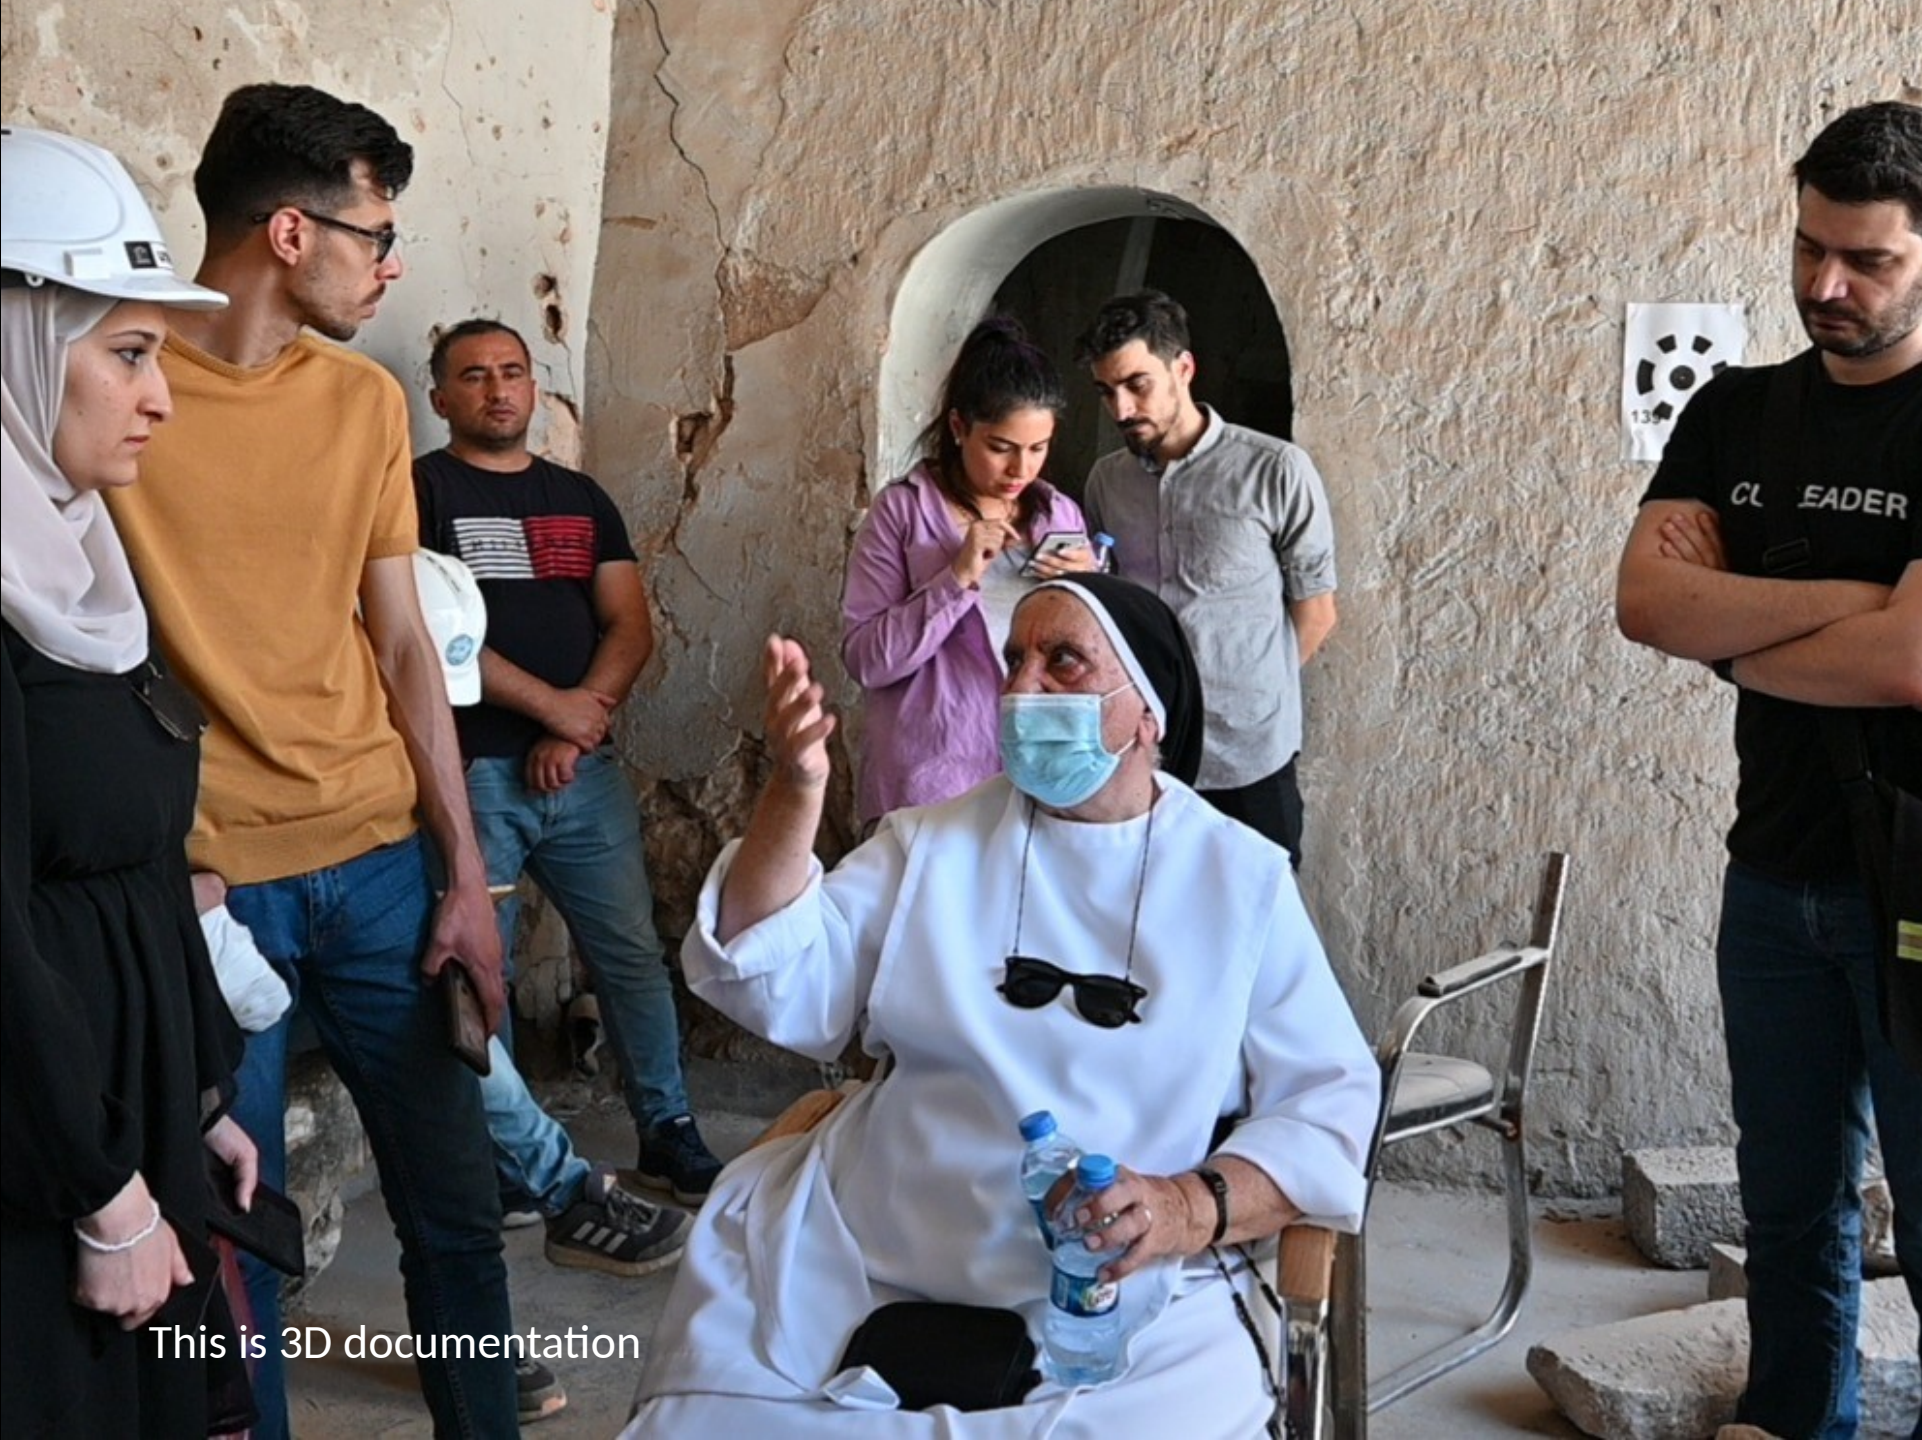
This is 3D documentation

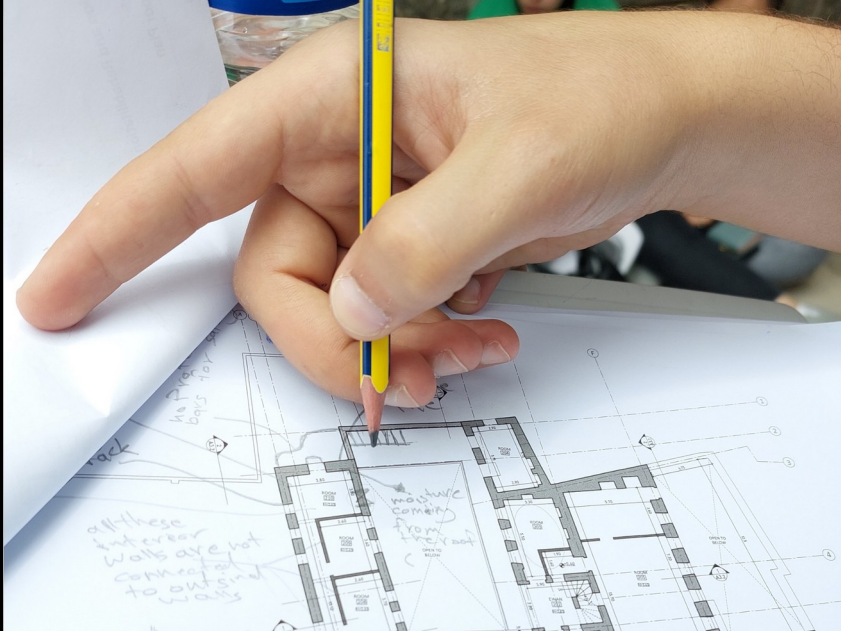
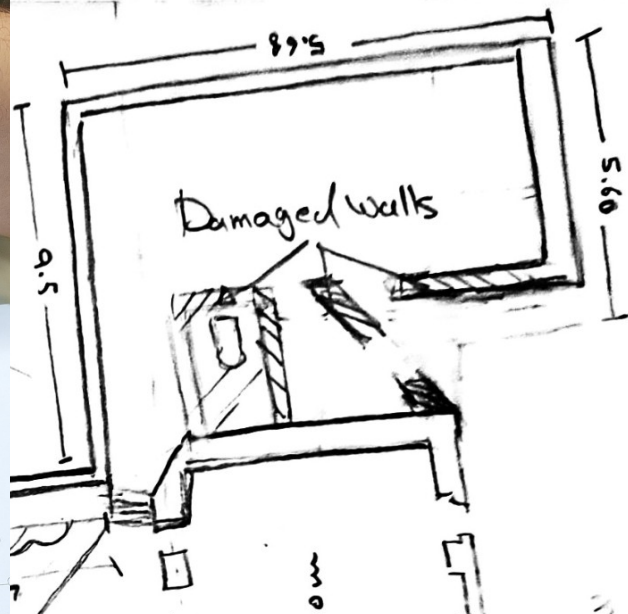
- olive tree historical value
- corners of the windows and doors are from alabaster
- the concrete floor needs to be removed, it has no value and not leveled good soils causing moisture damage to the basement
- thickness of concrete brick wall is 40cm
- thickness of stone walls 60cm

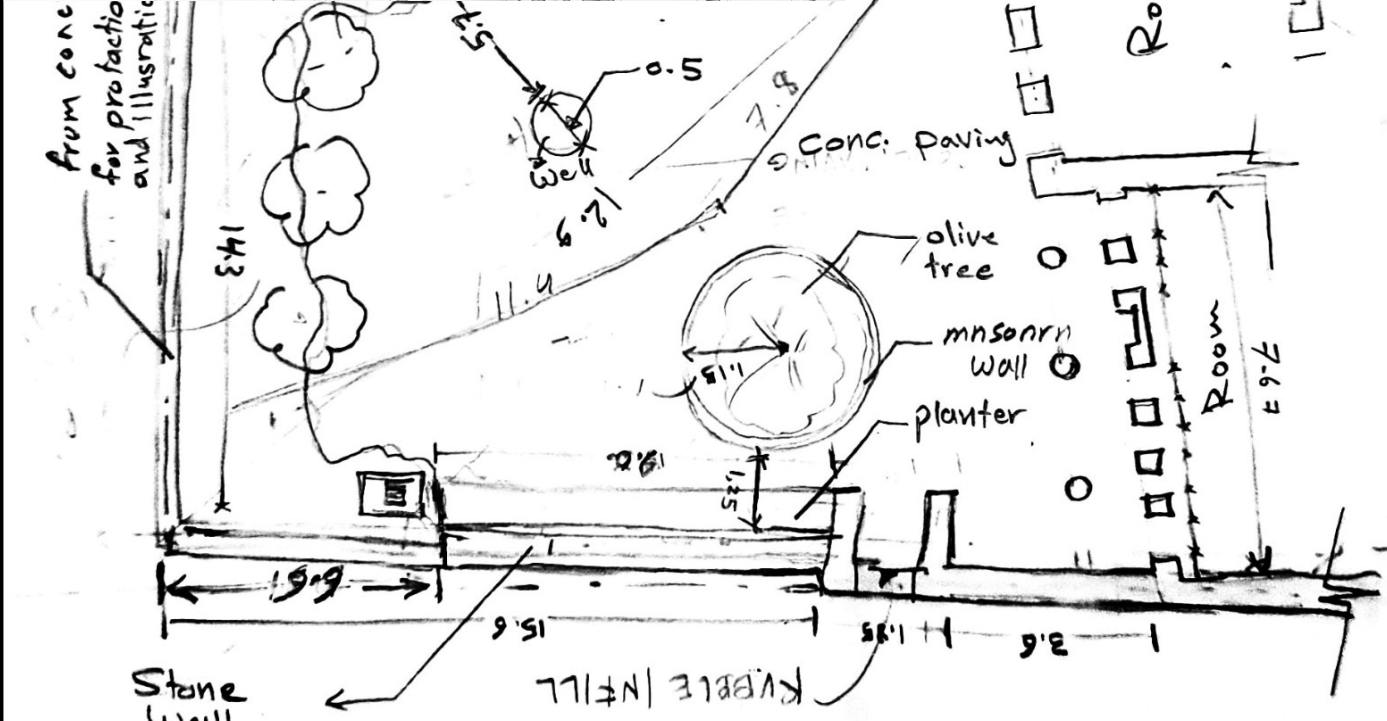
Plan of exterior yard of the prayer house

Free hand drawing

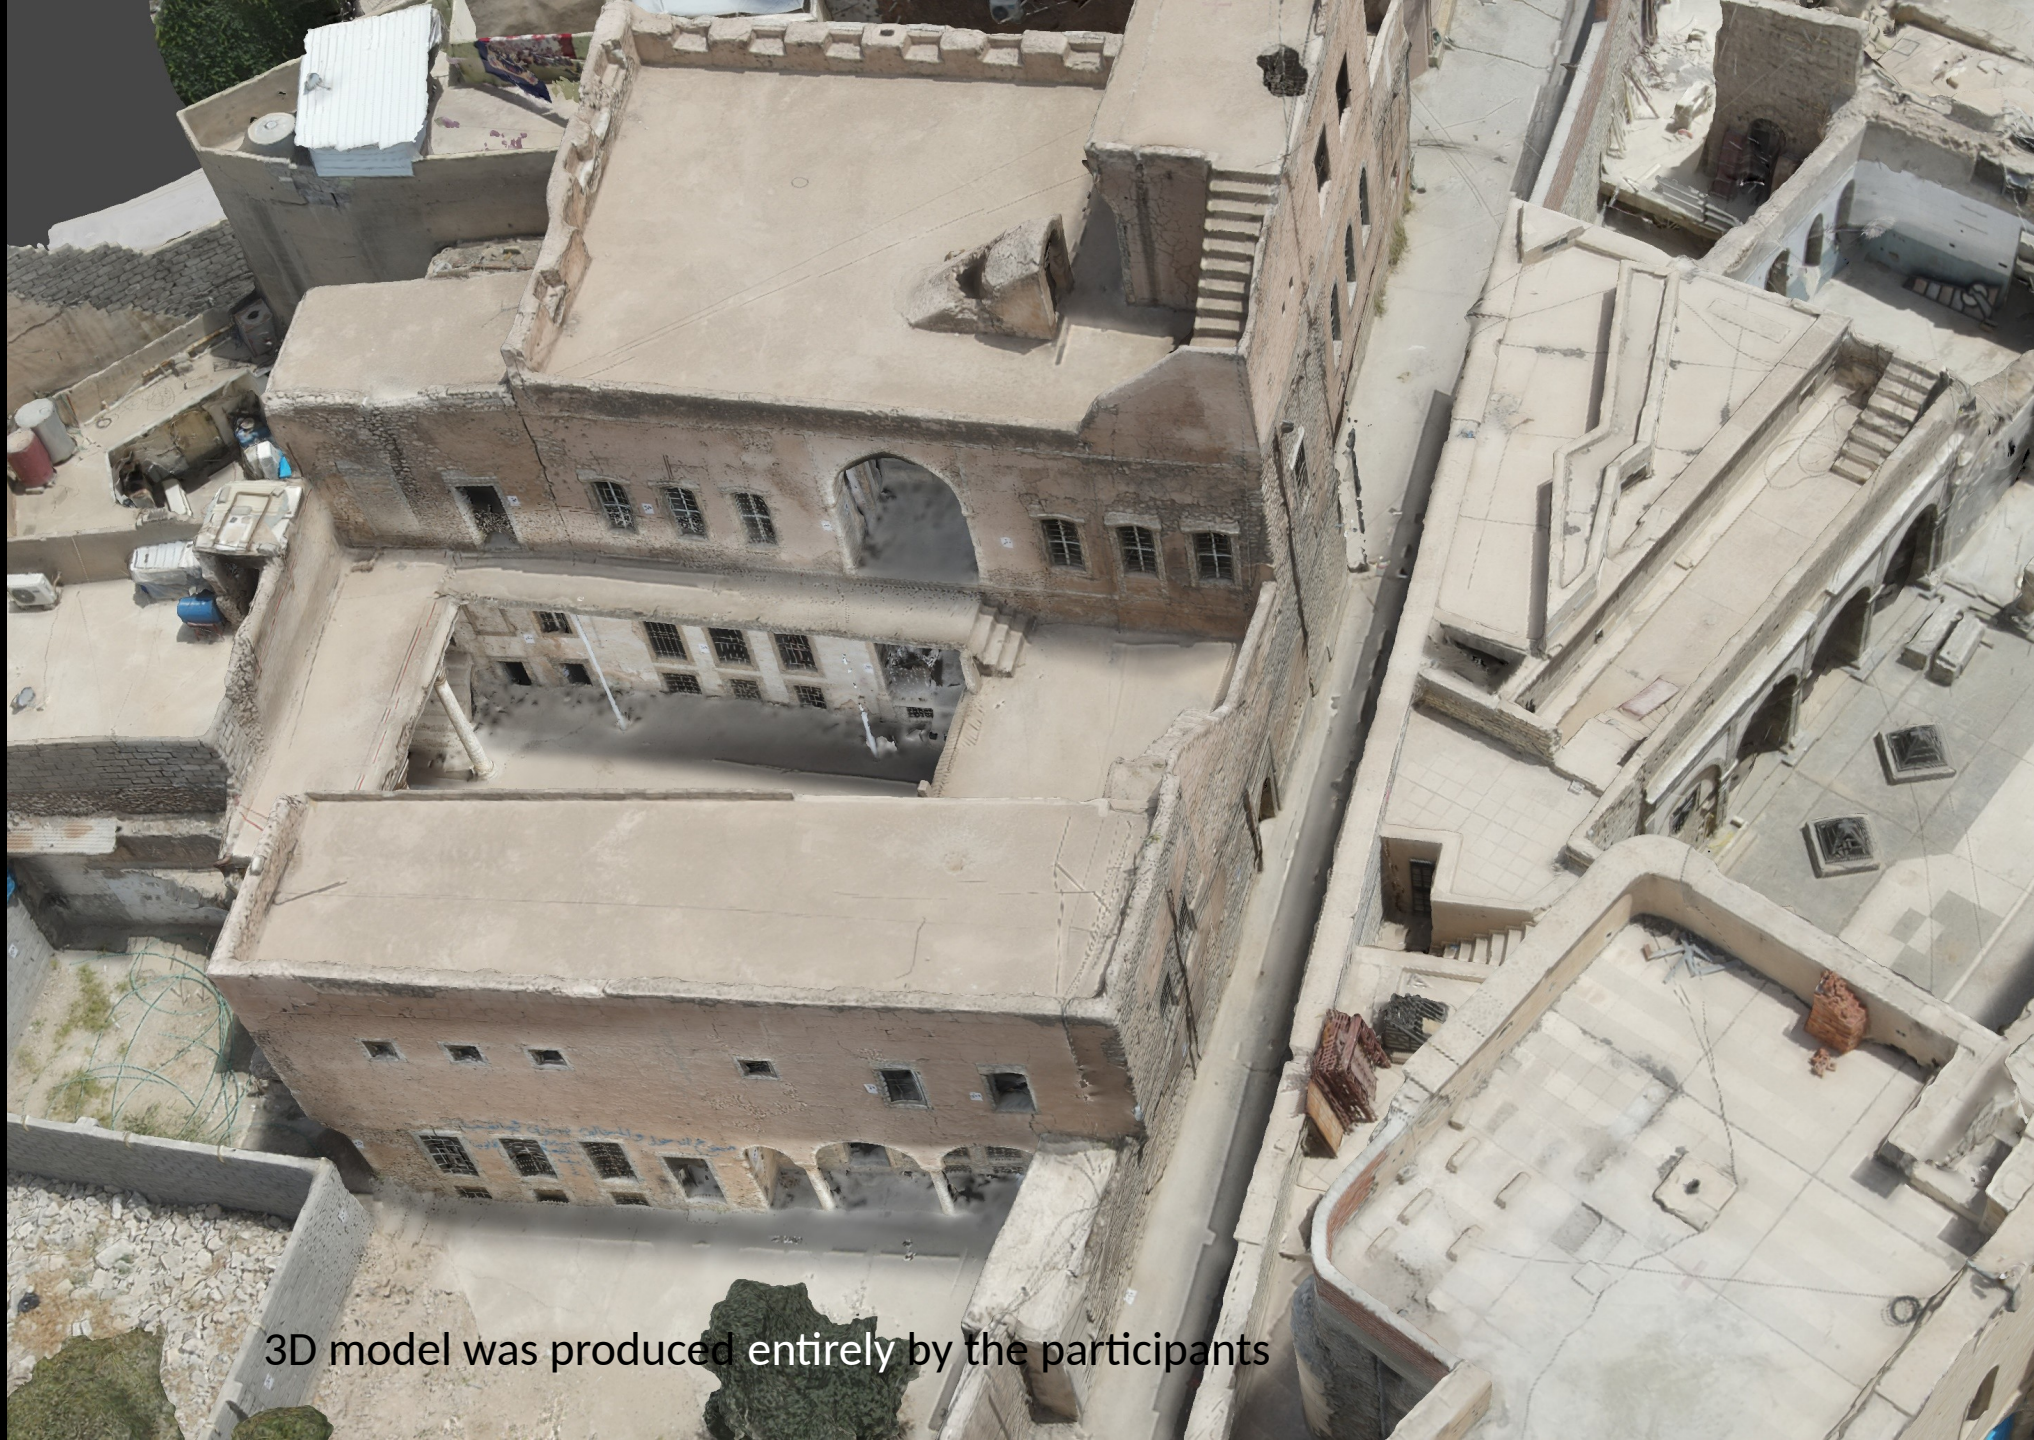
3D model was produced entirely by the participants

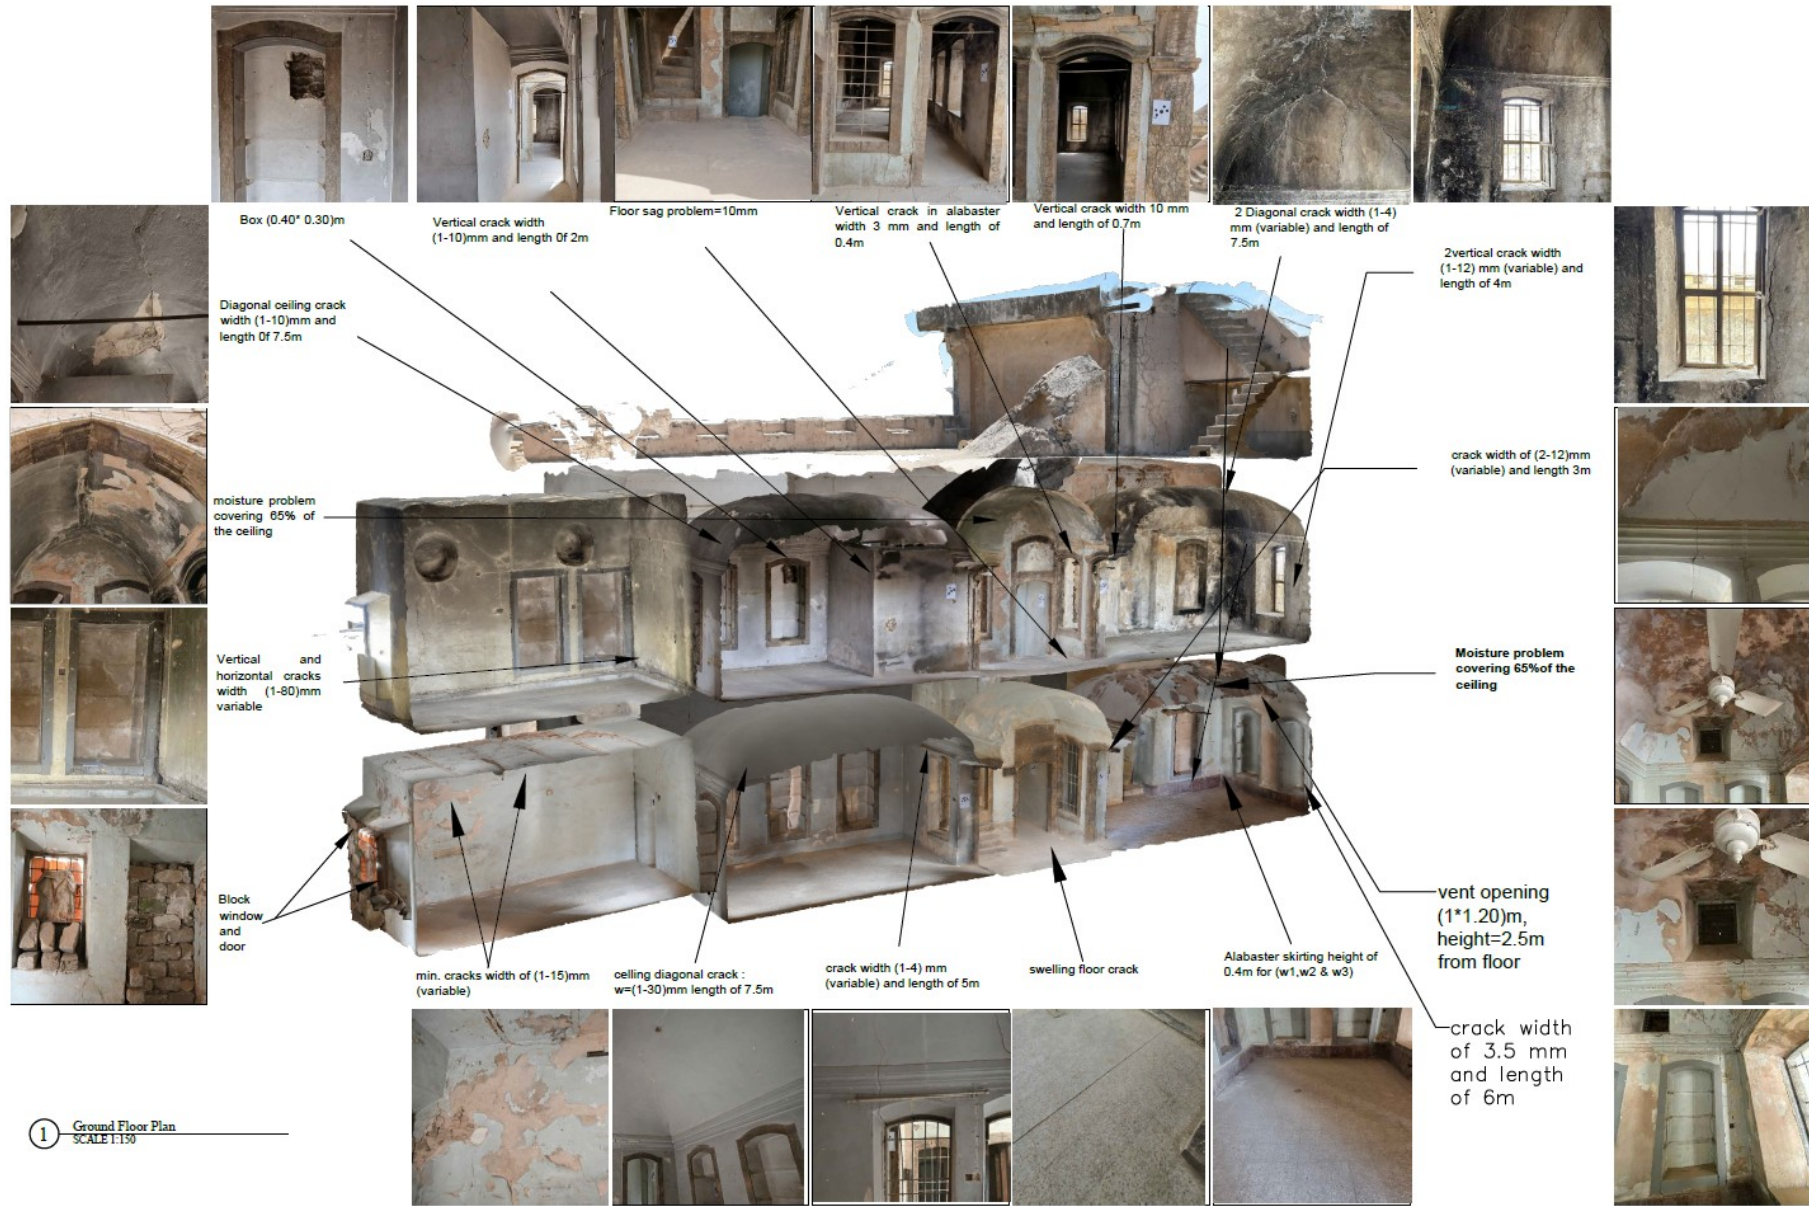
A1.2

Project:  
Restoration and Rehabilitation of The  
Prayer House  
Drawing Title:  
Interior Axo 1

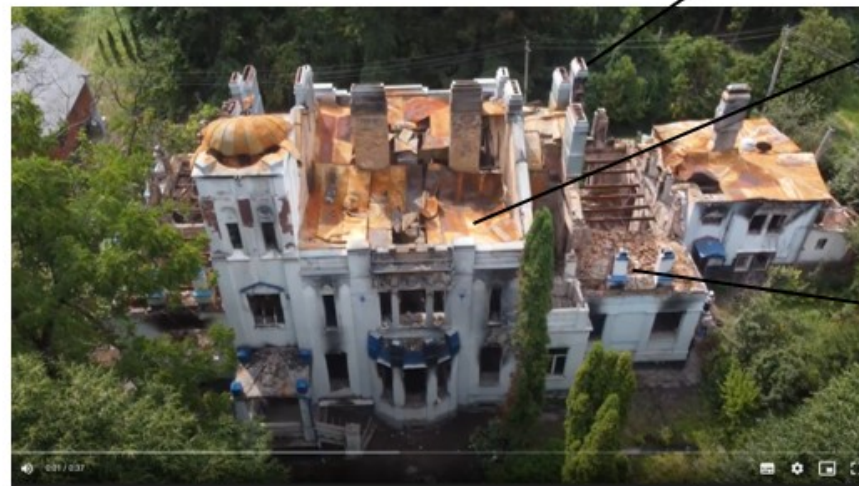
Tall slender chimneys have lost their lateral support

Remaining metal roof cladding removed to prevent accumulation of snow load

Horizontal areas to be cleaned and inspected. If unstable propped to support snow load

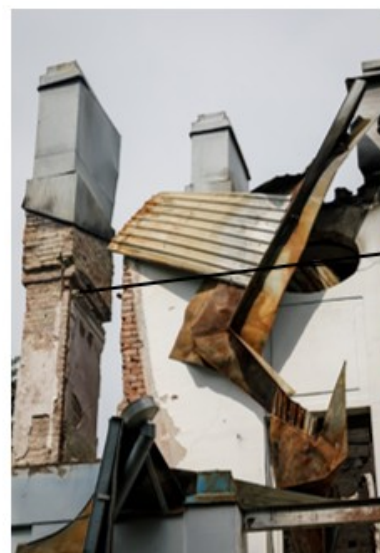
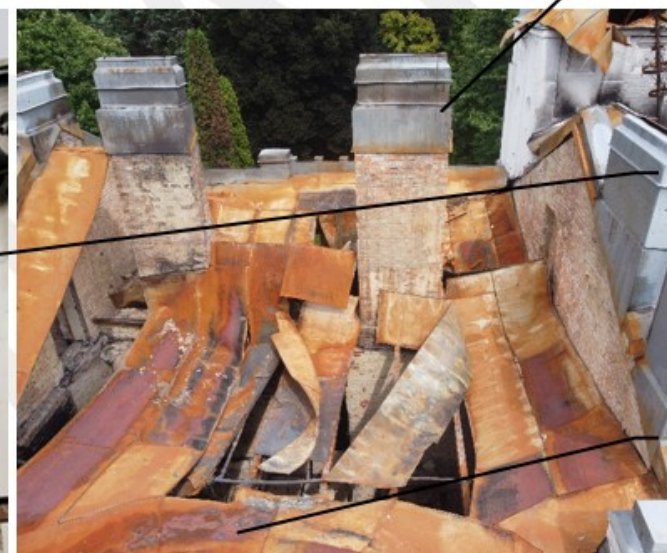
Assess existing coping and secure on chimneys and wall tops

Tall slender chimneys have lost their lateral support must be stabilized.

Remaining metal roof cladding removed to prevent accumulation of snow load
