ICCROM Heritage Recovery Program Module 4 - Documentation Of the Prayer House Of Our Lady Of The Hour Church, Mosul

Restoration and Rehabilitation of The Prayer House

Drawing Title: **Key plan**

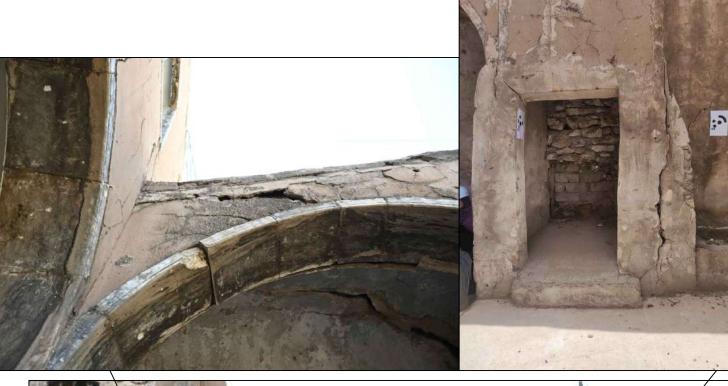
the small door Exhibition to collapse

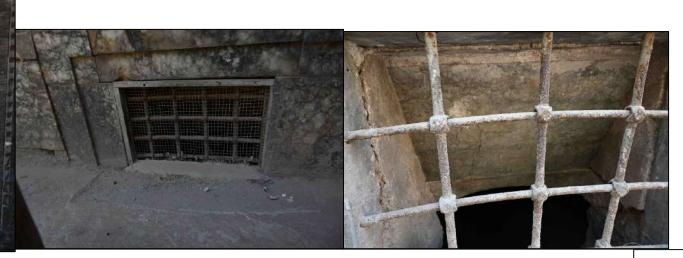
there is to types of protection bars of the windows old and new which are different in shape and spacing

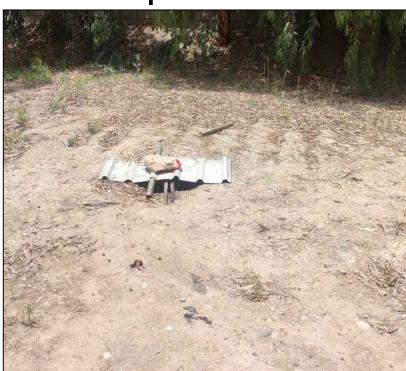
their is a wellwithout protection

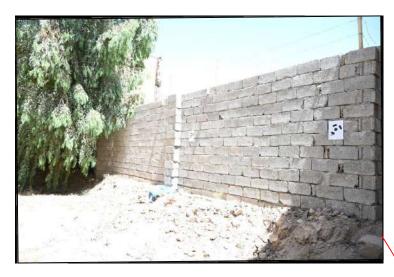
concrete
Block fence
has use
value for
privacy

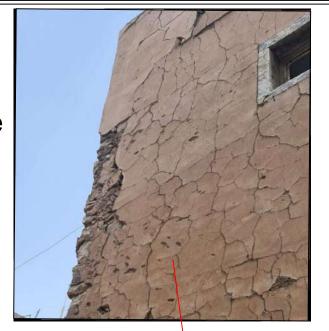
the facade"s plaster has a unique colour worth to save

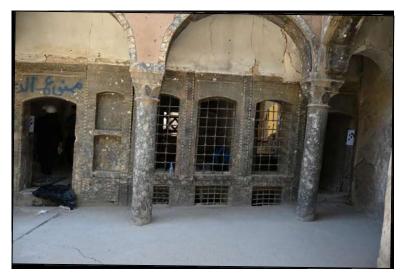
Alabaster facade and its color has unique value

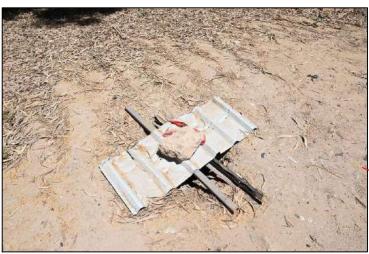
well has use value for supply water for different uses

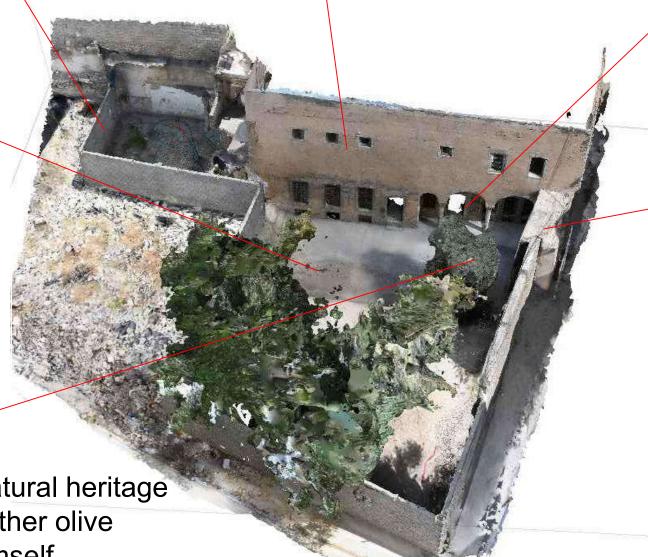
closed
door has a
use value
like if we
reopened
it to reuse
in
construction

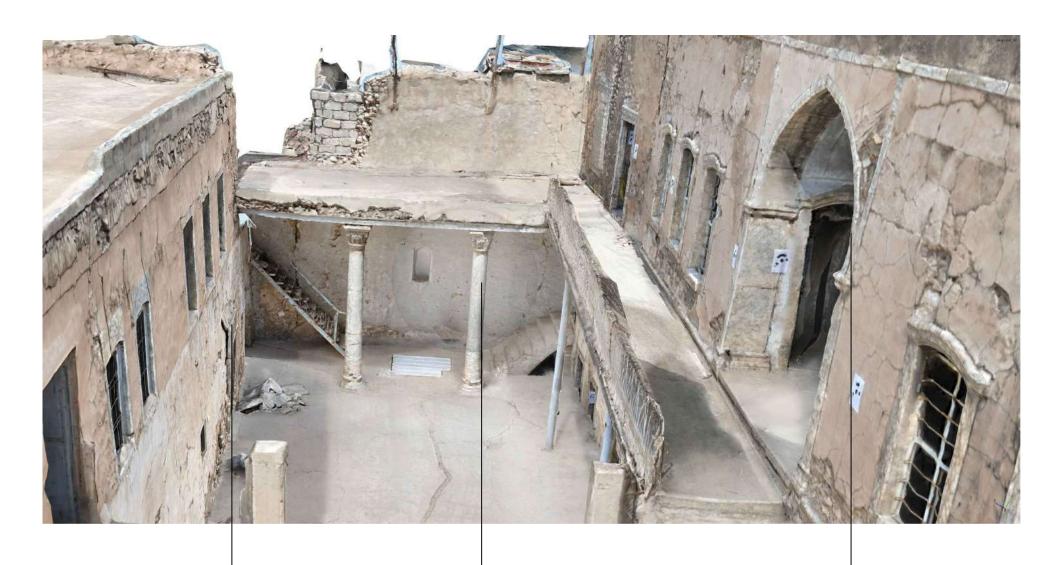
The old entrance in the left part of the main courtyard which is reuse from another church

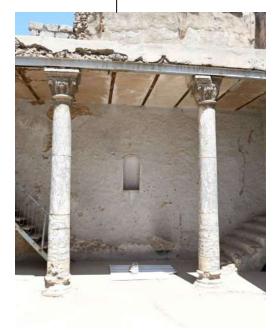
The old columns in the main courtyard which is reuse from another church

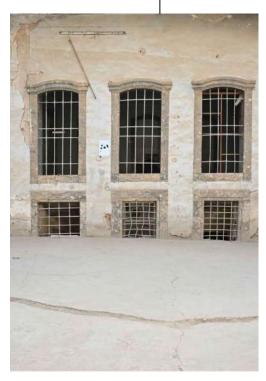
The windows in the prayer house are like the windows in any old house in Mousl

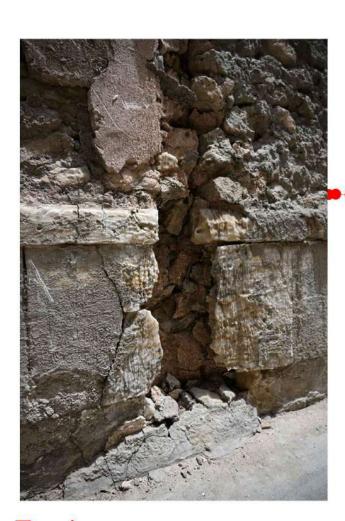
Erosion

The erosin of alabaster in the facade which called Medmak because of the bad water drinage of the prayer house and it is came from up floor

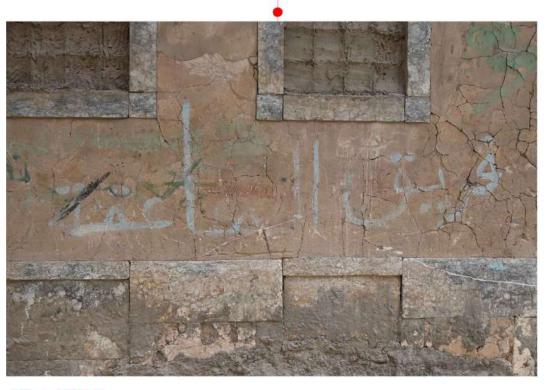
Un covered steel

I section in the facade which left room in the first floor the material is removed and that cause rust to the steel

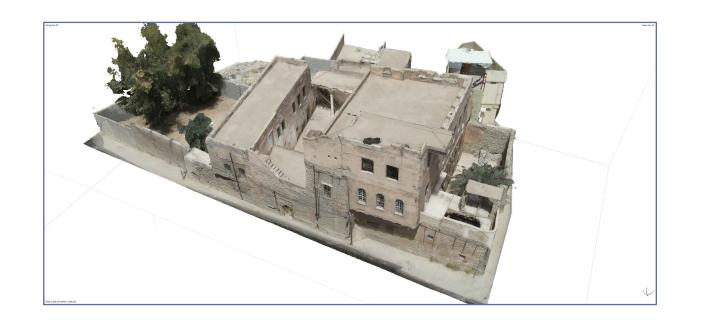
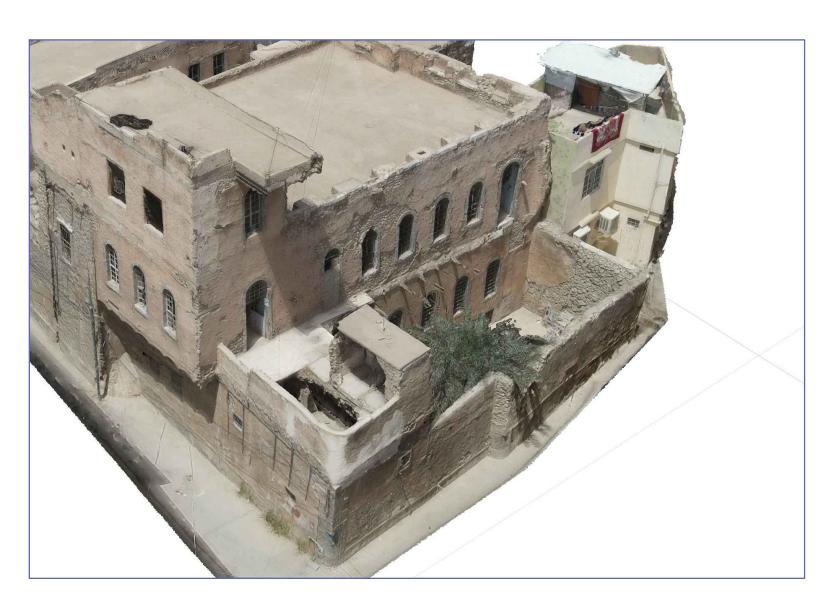
Drawing Title: **Drainage Conditions**

roof drainage
